Historic Building Assessment for the Deerfield Town House

10 Church Street, Deerfield, New Hampshire

Mae H. Williams, Preservation Consultant and
Stephen Bedard, Bedard Preservation & Restoration, LLC

Completed May 12, 2025

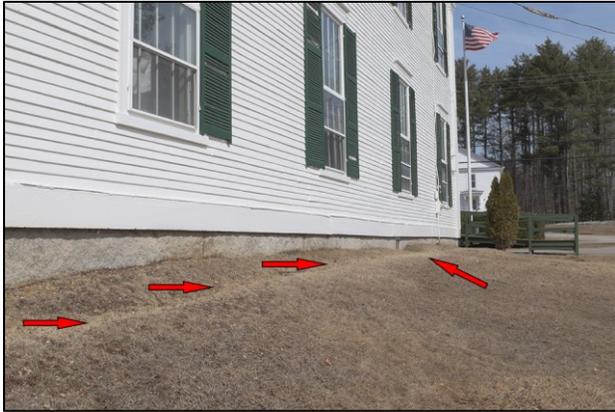
Figure 86: Hump along drip-line at east elevation

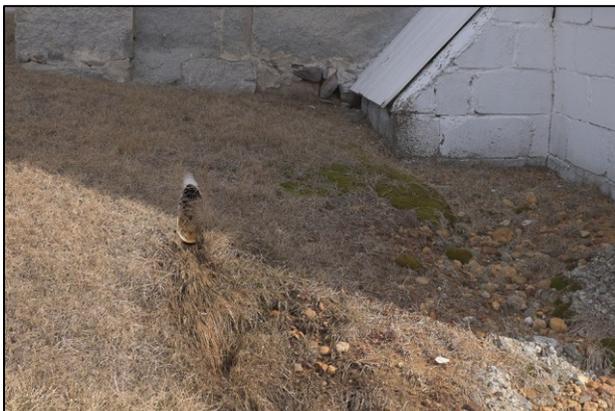
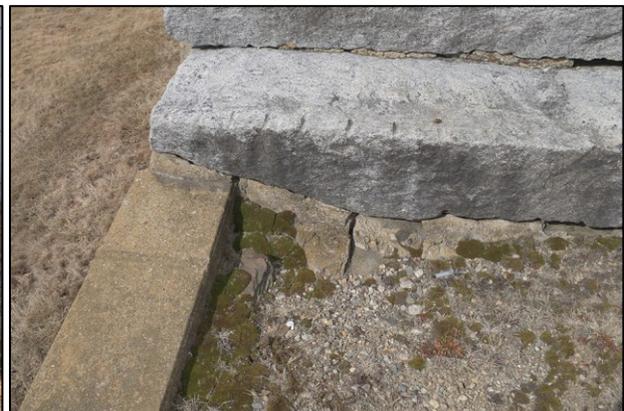
Figures 89 & 90: Erosion adjacent to basement sump-pump pipe at southwest corner of building (left) and uneven approach to 1885 egress stairs at southeast corner of building (right)

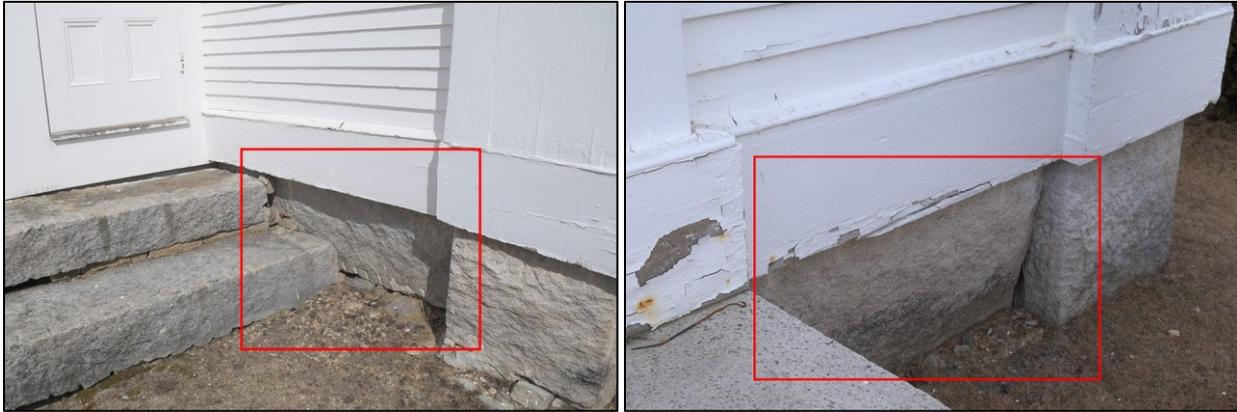
Figure 91: Tipped foundation stone at southeast corner Figure 92: Tipped foundation stone at northwest corner

Foundation - The granite underpinning of the Deerfield Town House is in overall good condition and appears to be largely stable. Close inspection reveals that two of the blocks have come out of plumb and begun to tip. One of these blocks at the northwest corner of the building, tips in at the base, and the corresponding block at the southeast corner is also tipped (figures 91 & 92). Though the building does not appear to be actively moving, the correspondence between the two corners of the structure suggests that a shift has occurred sometime in the past.

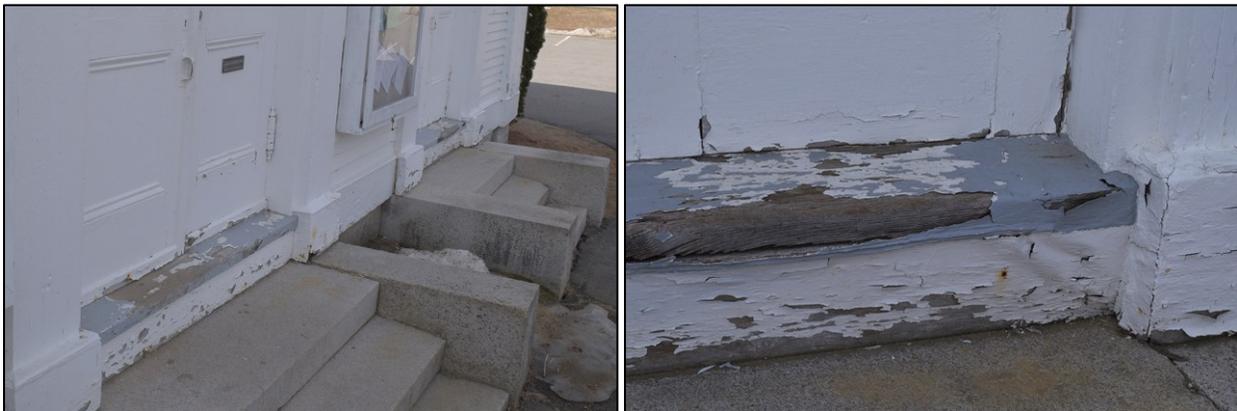
Figure 93: Damage to thresholds/pilaster bases

Figure 94: Detail northeast threshold damage

Where the base-board trim and pilaster bases run directly against the tops of the granite entry steps, woodwork has begun to rot with boards bowing and significant paint-loss due to capillary action sucking

standing water up from the granite surface (figures 93 & 94). The wooden thresholds of all three of the primary (north) doorways are all significantly deteriorated with considerable paint-loss and rot. The water has clearly wicked up through the thresholds and into the lower sections of some of the doors, and there is particular paint-loss at the bottom rail of the northeast entrance, where this has been exacerbated by the flat landing of the ramp (figure 95). Similarly, the bottom sections of corner boards and clapboards directly above the water-table that runs along the base of the exterior walls shows signs of water-damage over time.

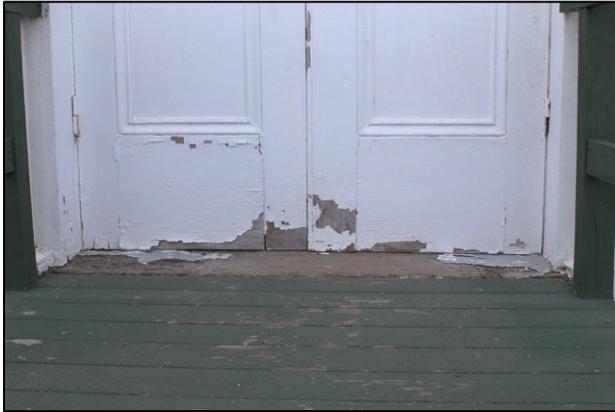
Figure 95: Damage to lower section of northeast door

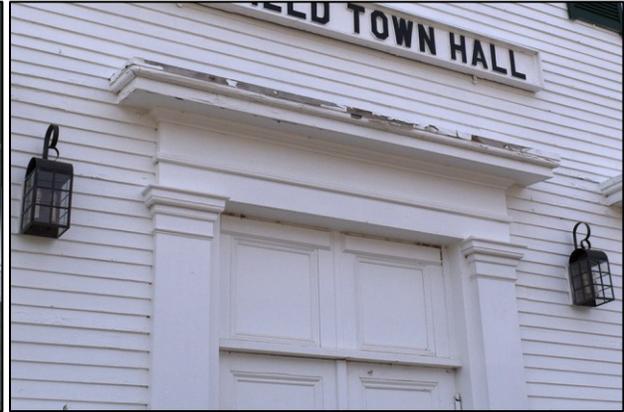
Figure 96: Damaged entablature, center door

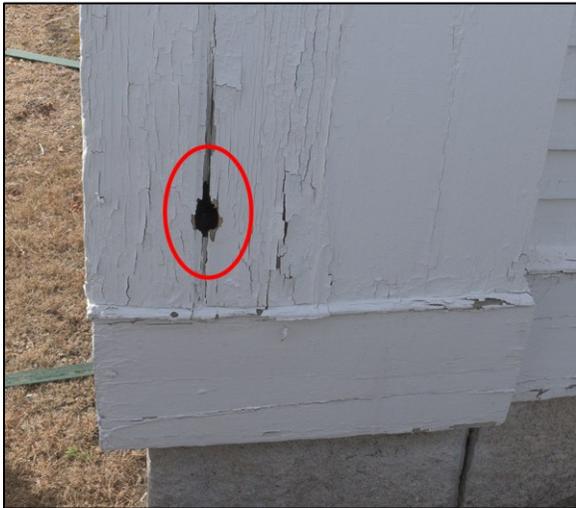
Figure 97: Rodent hole, northeast pilaster

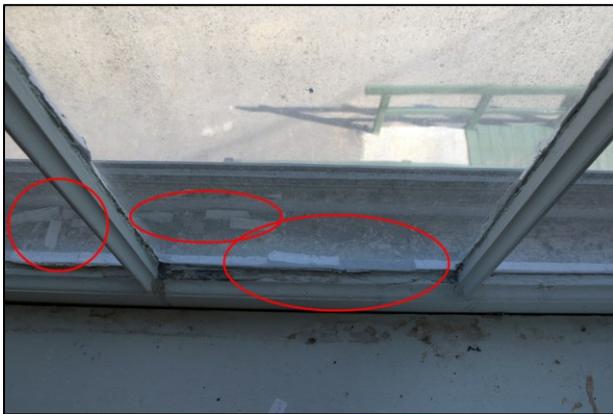
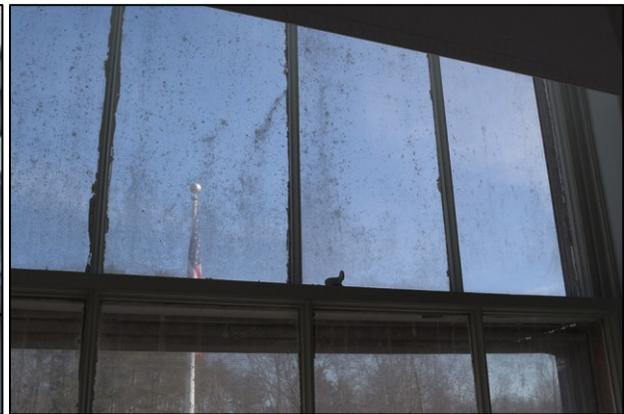
At first glance, the windows appear stable behind their mid-20th century exterior aluminum storm windows (figure 98). The trim around the windows is in good condition, with some paint loss to the sills, however, the sashes themselves are in fair to poor condition. The window glazing has failed significantly on the sash, leading to lose panes of glass, particularly at the north elevation (figure 99). Poorly ventilated storm windows appear to have created a micro-climate in some of the windows where condensation between the exterior side of the historic sash and inside of the storms has been trapped, creating a very moist environment that has caused the glazing to fail, and black mold to form (figure 100).

Figure 99: Failed glazing at former selectman’s office Figure 100: Black mold on interior side of storm window

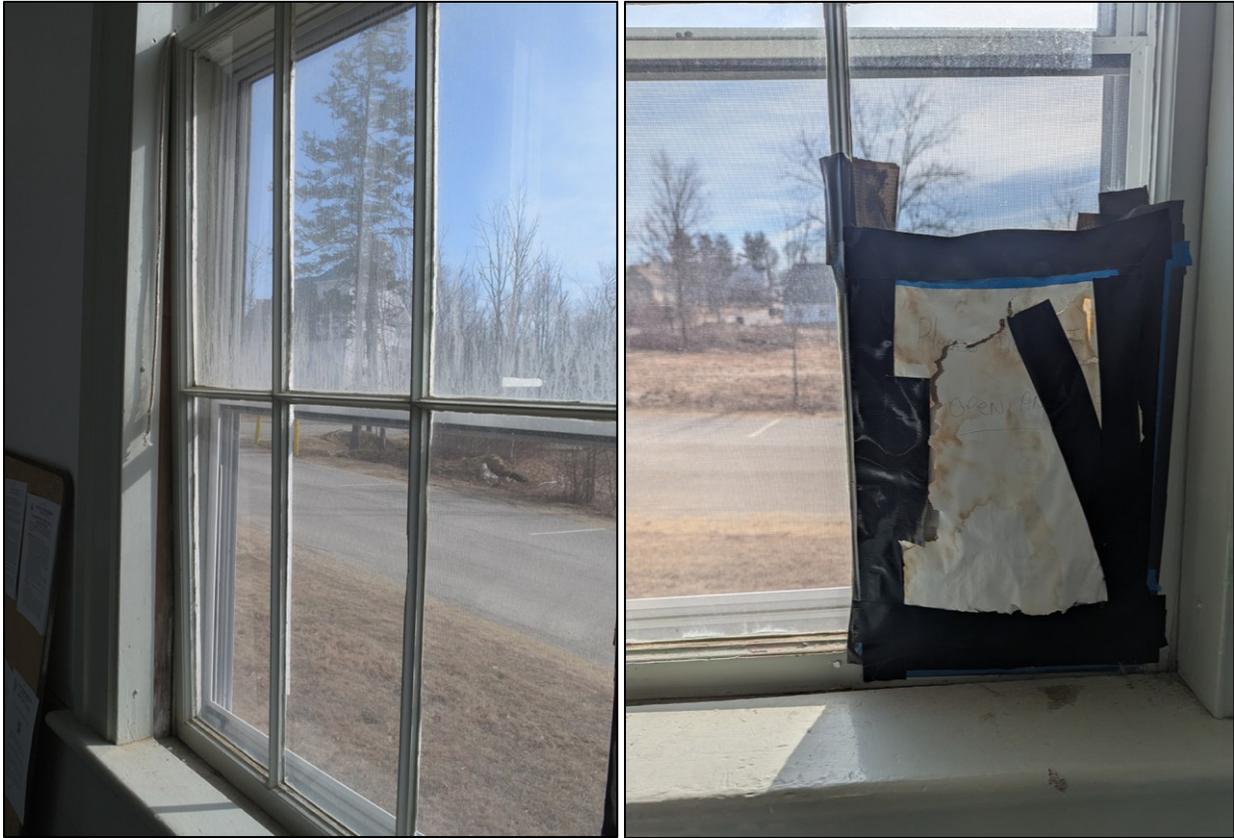
Figures 101 & 102: Broken sash cord & window no longer held in place (left) and broken window pane (right)

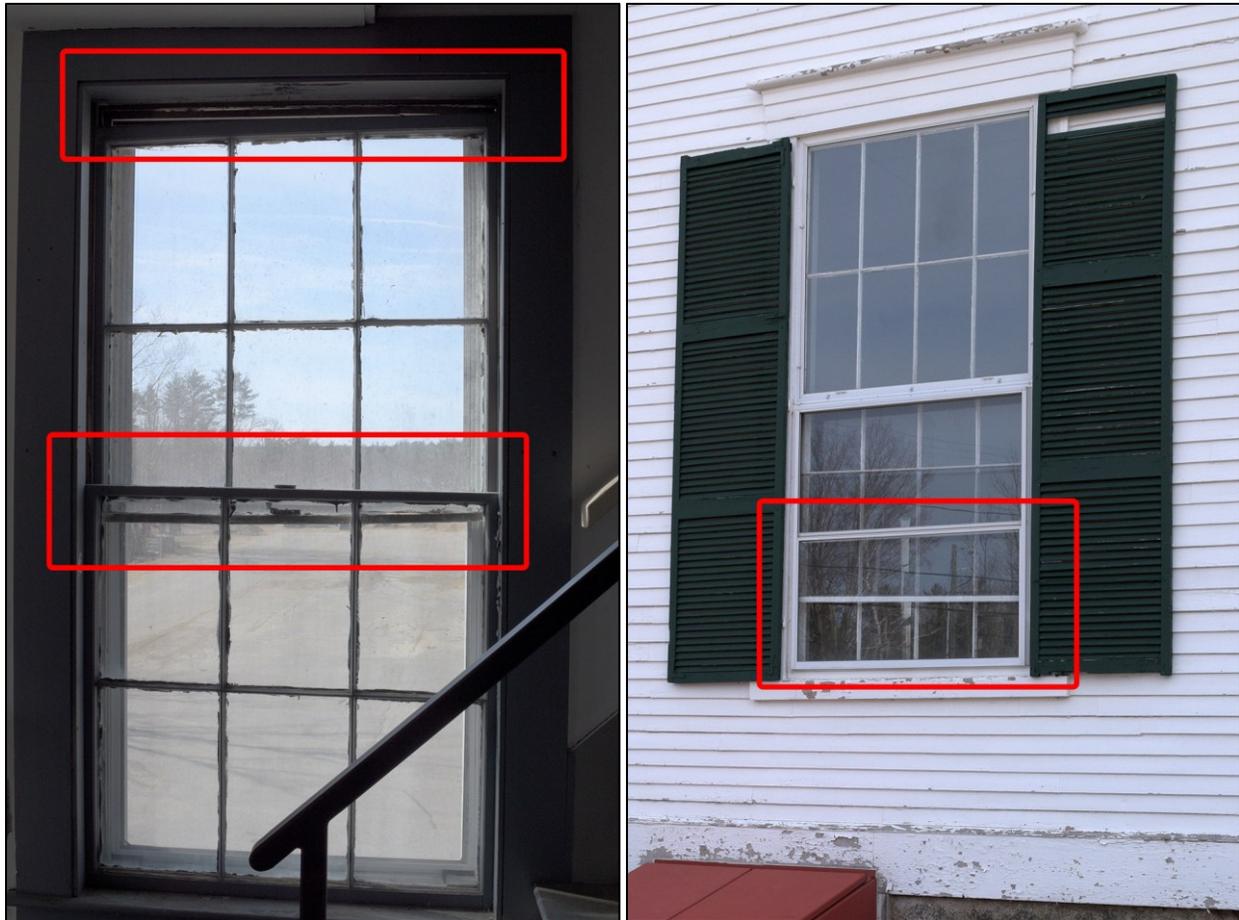
Figures 103 & 104: Damaged south window in 1885 egress addition (left) and aluminum storm window left open all winter (right)

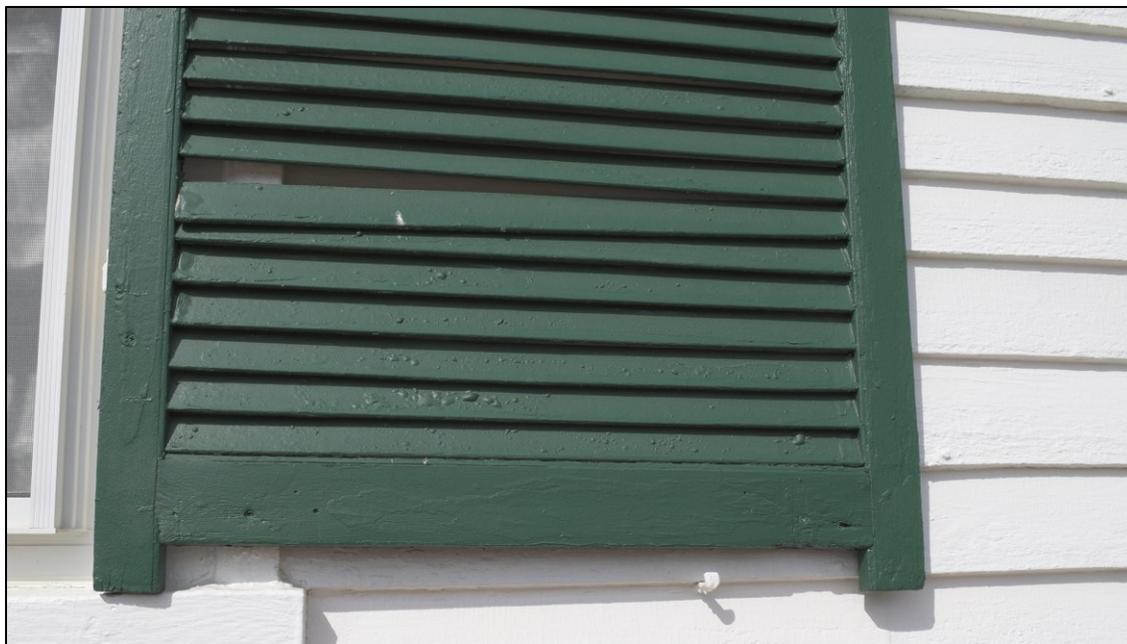
Figure 105: Exterior blind with bubbled paint on louvers

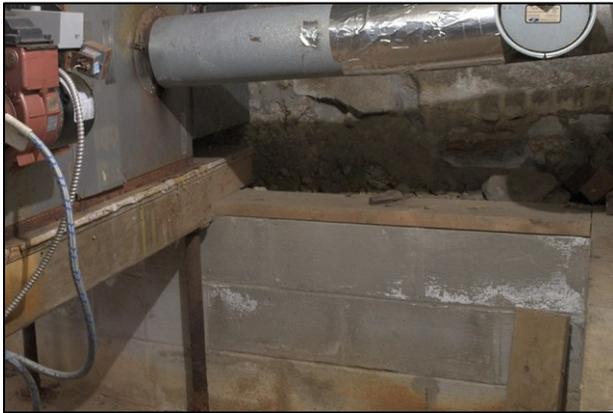
Crawlspace/Cellar – The small utility room that was excavated from beneath the midpoint of the west elevation of the building is in poor condition. The room, which was added ca. 1988, has always been plagued by moisture and was the site of a recent flood. Evidence of standing water in the space is seen by efflorescence and rusty staining to the concrete block at the interior walls, below the original crawl-space depth (figure 110). The interior walls separating the room from the adjacent crawlspace and ceiling are sheathed in gypsum board, which is flecked with black mold (figure 111). The lower section of wall at the northeast corner of the room, adjacent to the door to the crawlspace and a water spigot is severely damaged and completely rotted away, revealing the fiberglass batt insulation and 2x4 framing on which it sits (figure 112).

Figure 110: Discoloration of concrete block

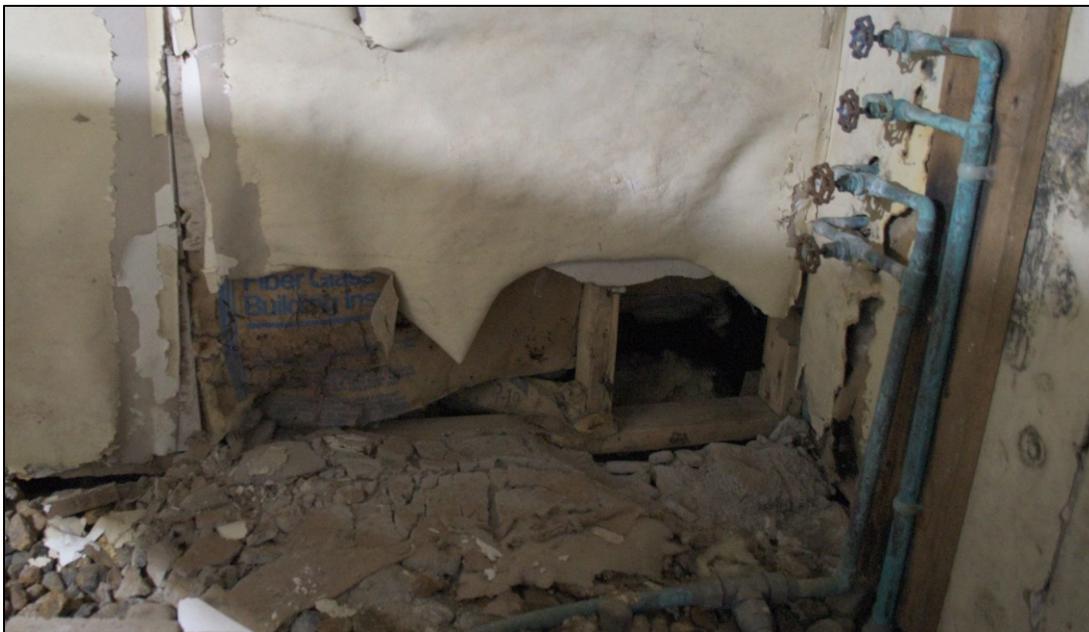
Figure 112: Damaged wall at northeast corner of utility room

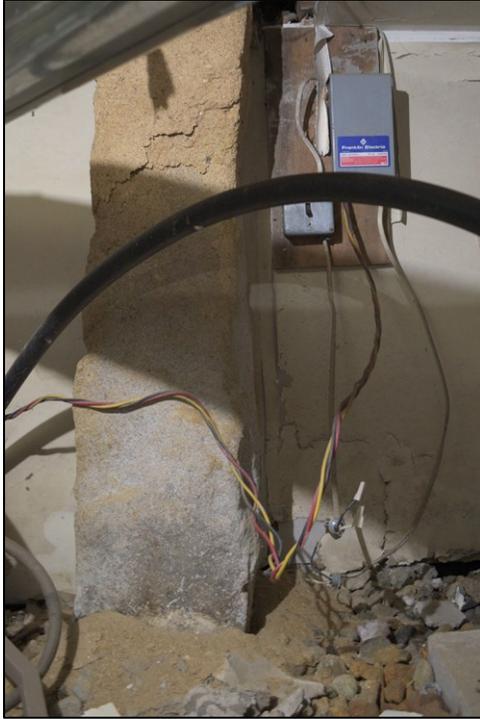
Figure 113: Damaged granite post

Of note, a granite post that is incorporated into the north wall of the room is heavily spalled, likely also in conjunction with perennial moisture (figure 113).

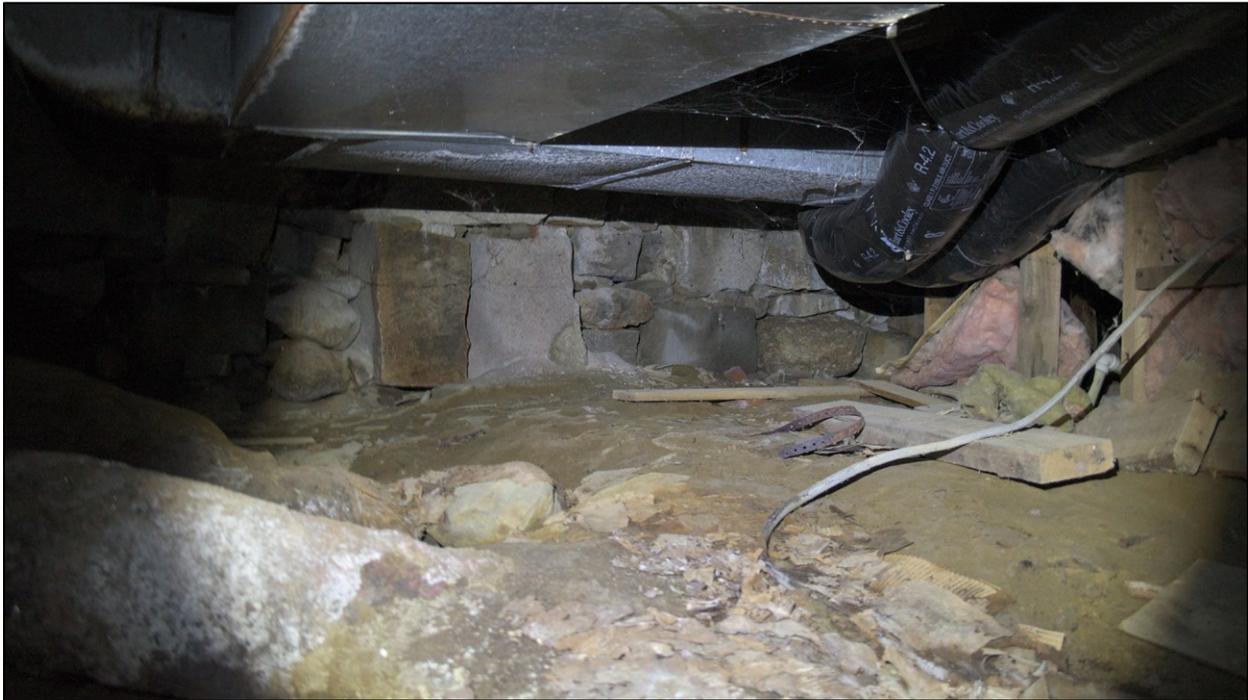
Figure 114: Crawlspace beneath building with rusted metal on dirt floor and damaged interior wall

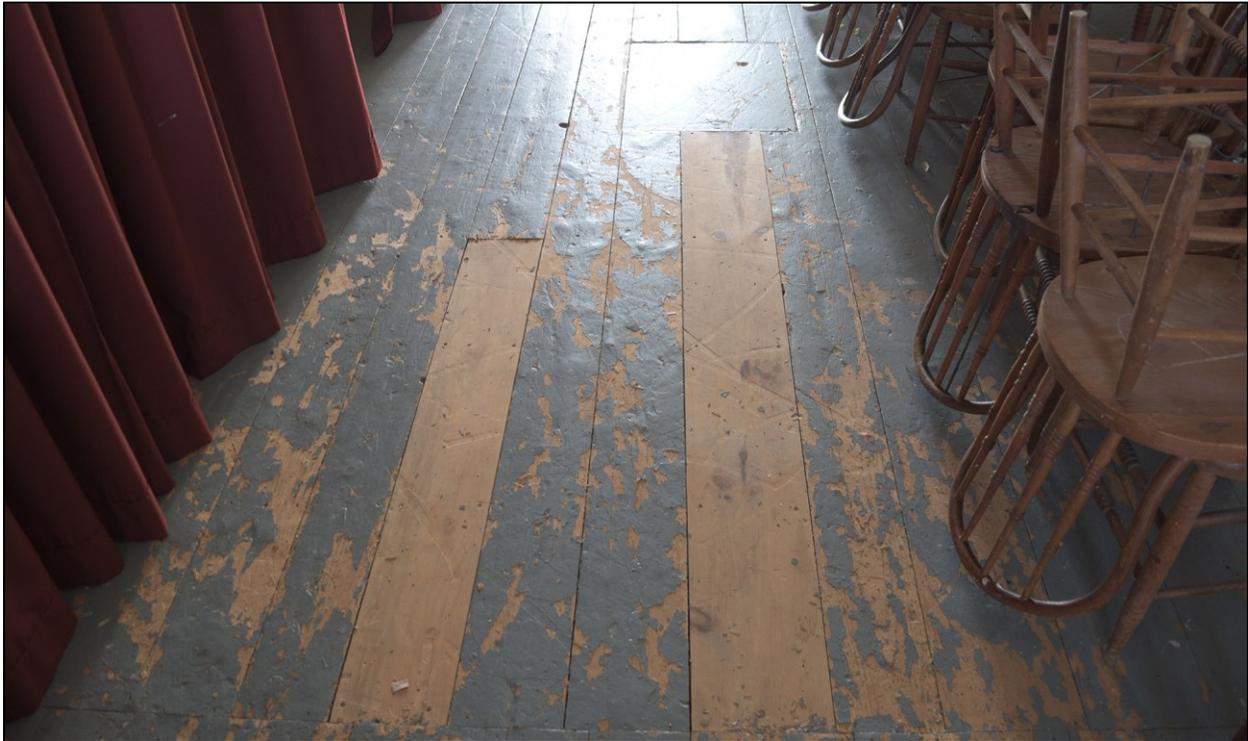
One area of damaged flooring was noted at the stage. Several of the softwood floorboards have been replaced, and the painted surface of the boards, especially at the west side of the stage, is extremely worn (figure 115).

Figure 115: Extremely worn floor of stage, facing east (note square hatch at center of floor)

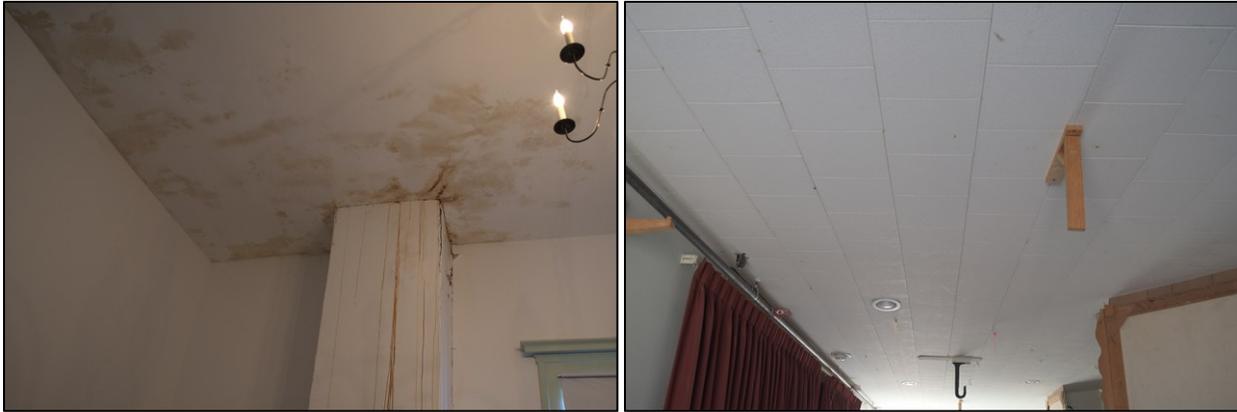
Figures 116 & 117: Historic staining to the ceiling of the former town clerk's office (left) and mid-20th century ceiling tile at stage (right)

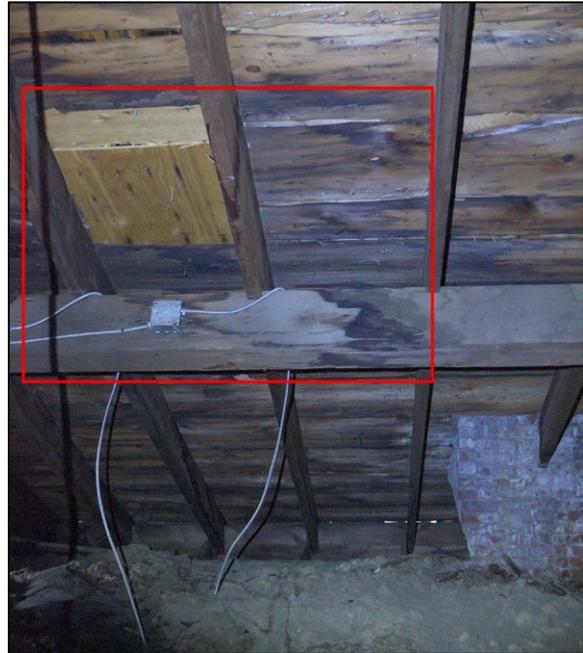
Figure 118: Historical roof leak at west roof slope

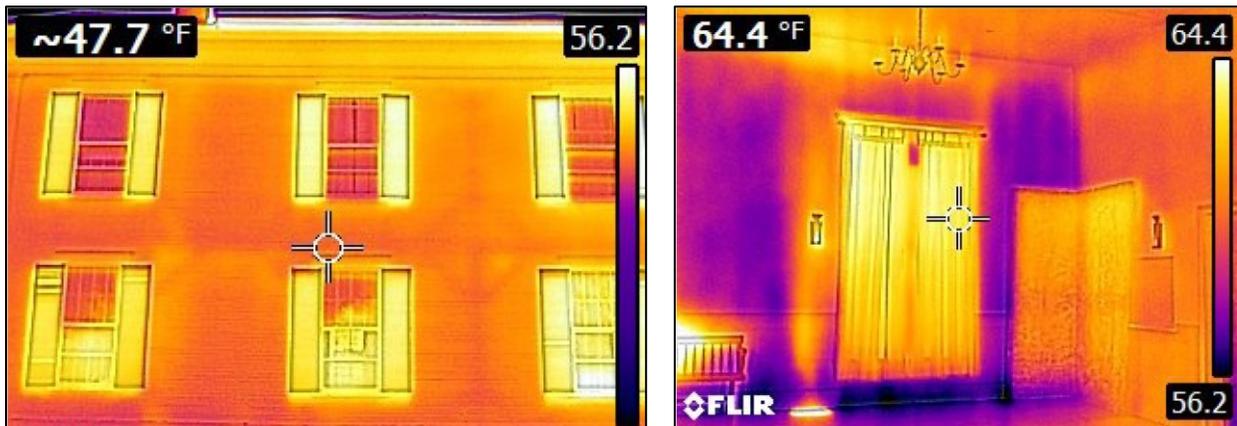
No visible wall insulation was observed during either site-visit, and there is no known record of insulation having been added to the wall cavities. It is assumed that there is little, if any, insulation in the walls of the Deerfield Town House, a supposition substantiated by evidence gathered as part of the 2021 energy audit by Margaret Dillon/S.E.E.D.S. which captured thermographic images of the building walls (figures 119 & 120).

Figure 119 & 120: Thermographic images of Deerfield Town Hall exterior walls from outside (left) and inside (right) (Dillon/S.E.E.D.S. 2021 Energy Audit, 9)

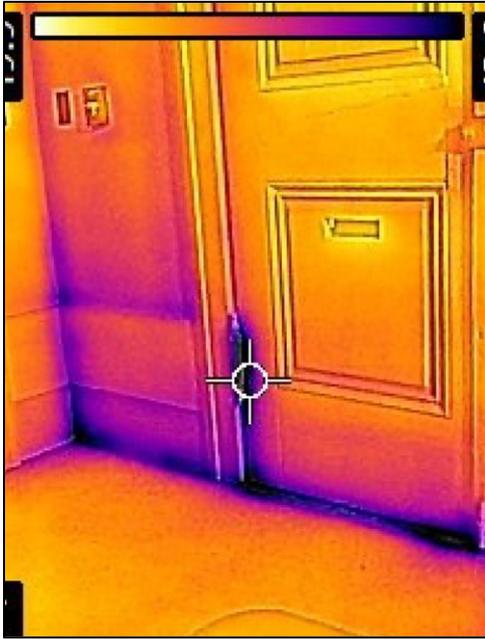
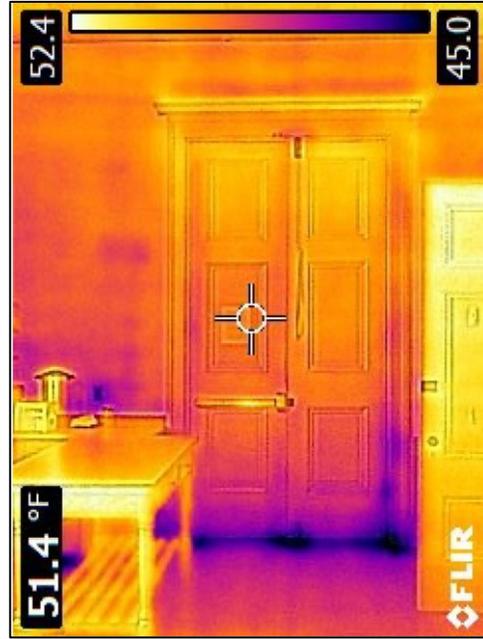
Figures 121 & 122: Thermographic images of primary entry (left) and northwest entry through kitchen (right) illustrating lack of weather-stripping and air leakage under doors (Dillon/S.E.E.D.S. 2021 Energy Audit, 12)

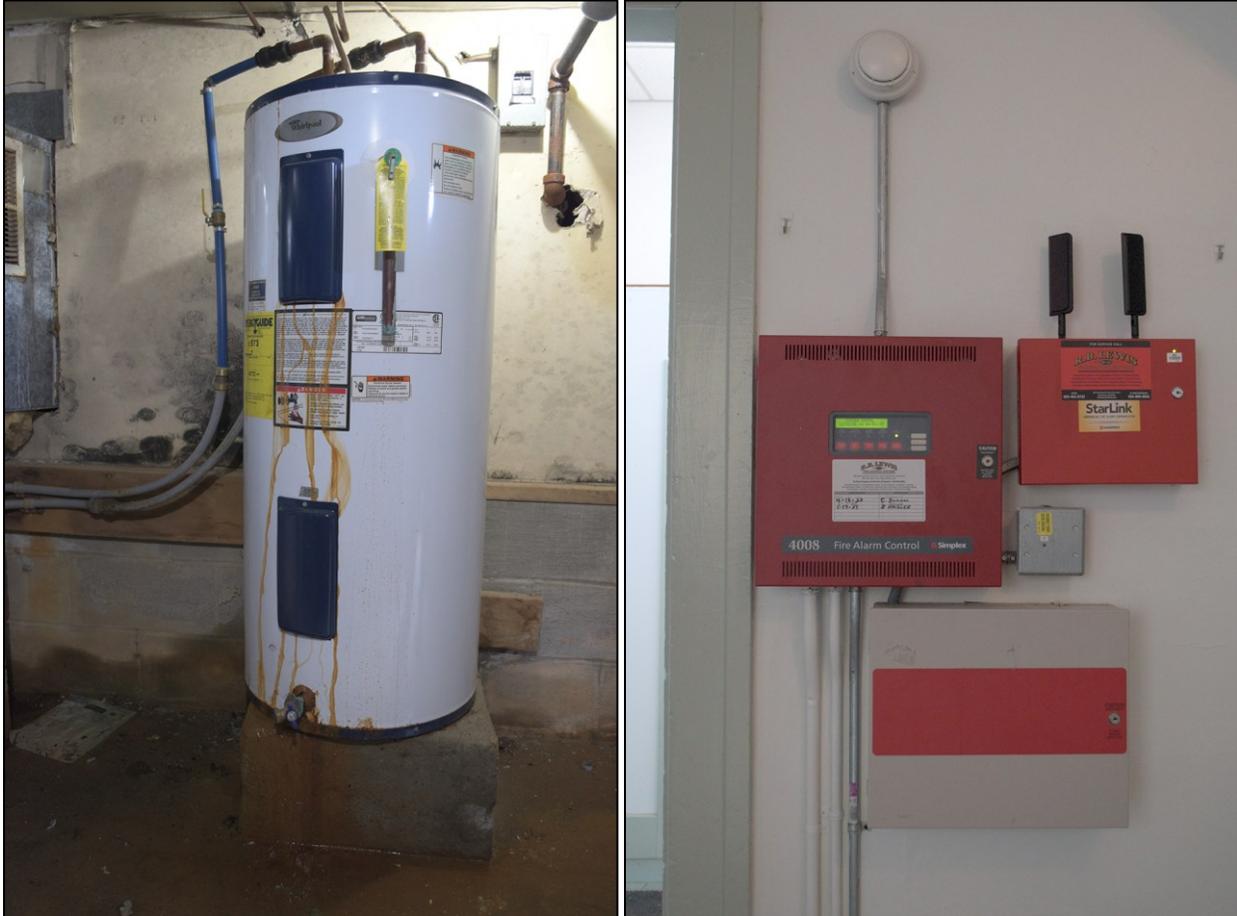
Figure 130: Rusted hot water heater (replaced March 2025) Figure 131: Fire alarm system (located in vestibule)
