Historic Building Assessment for the Deerfield Town House

10 Church Street, Deerfield, New Hampshire

Mae H. Williams, Preservation Consultant and
Stephen Bedard, Bedard Preservation & Restoration, LLC

Completed May 12, 2025

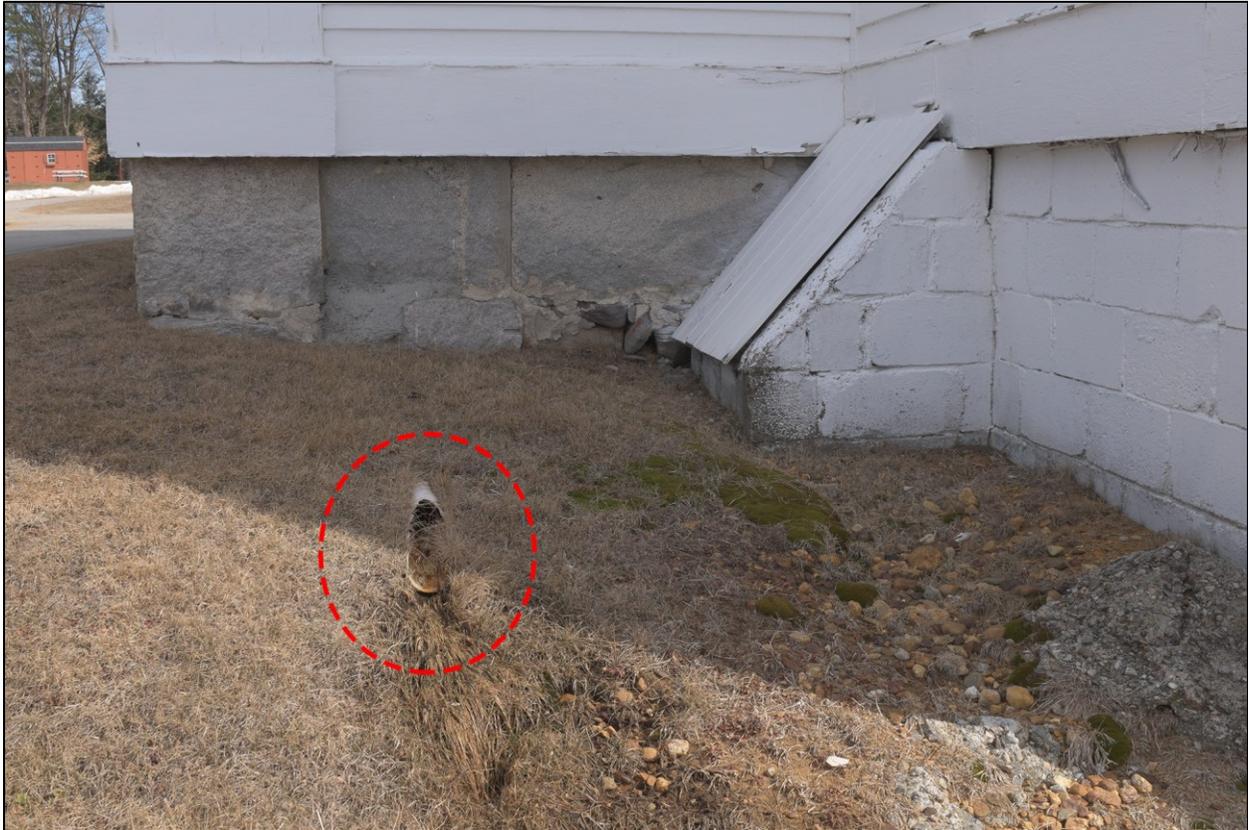
Figure 36: Drain pipe for sump pump in 1988 basement furnace room at southwest corner of Town House

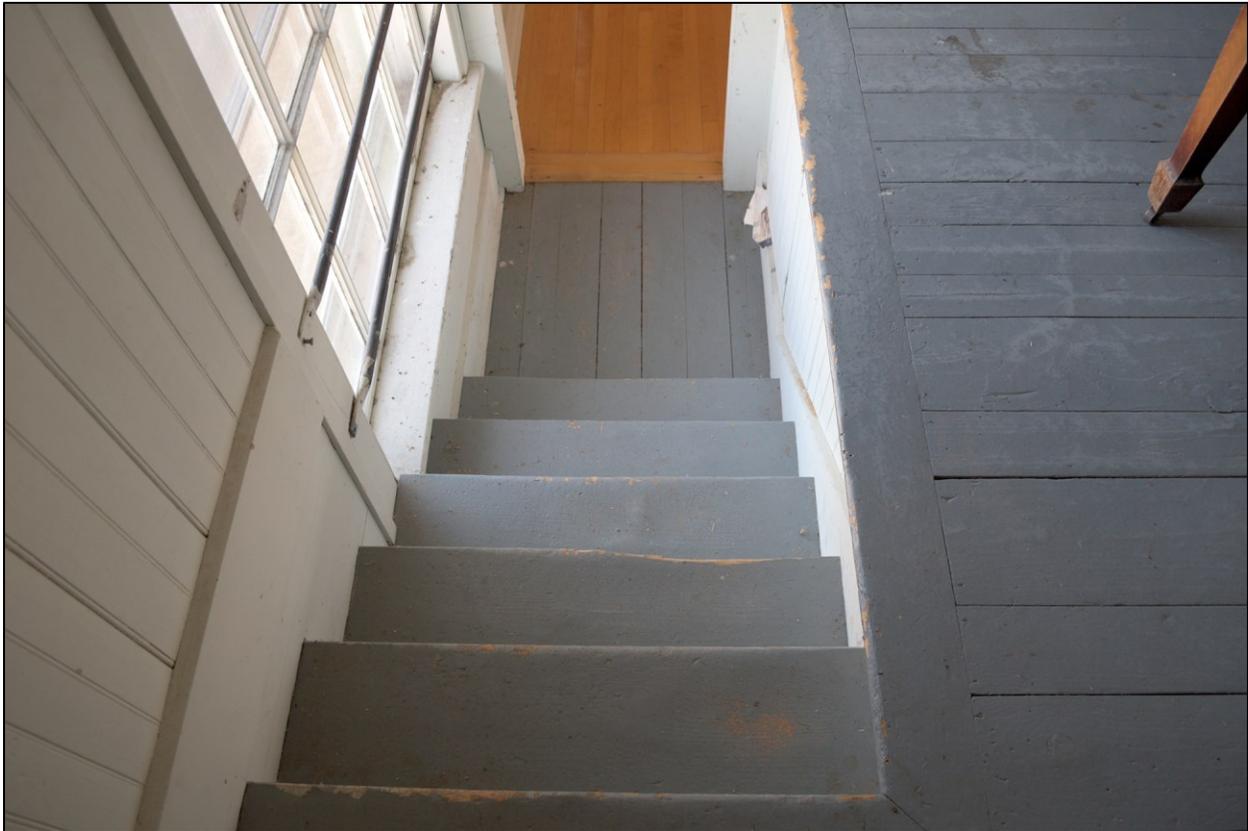
Figure 62: Worn steps leading up from west side of Upper Hall to backstage area

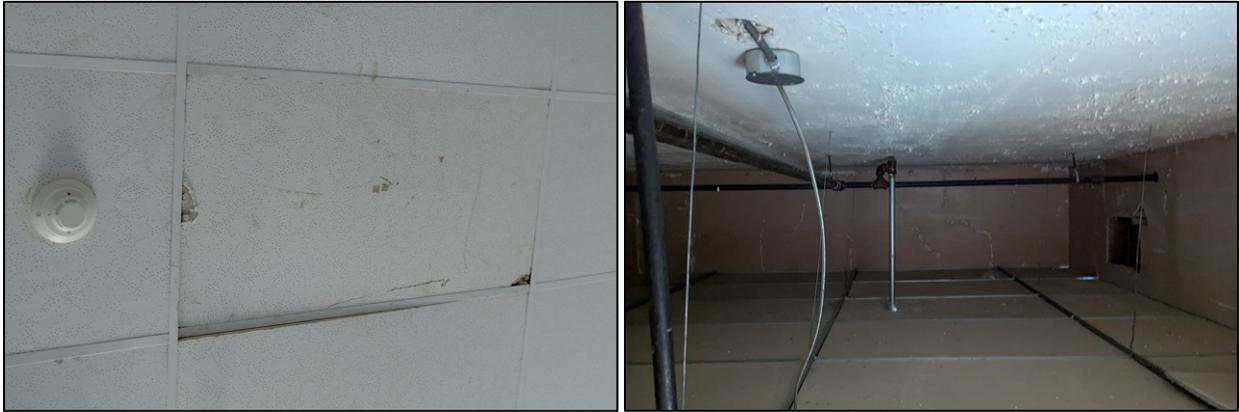
Figures 69 & 70: Acoustic ceiling in stair hall below attic entrance (left) and cavity between drop ceiling and original plaster ceiling (right)

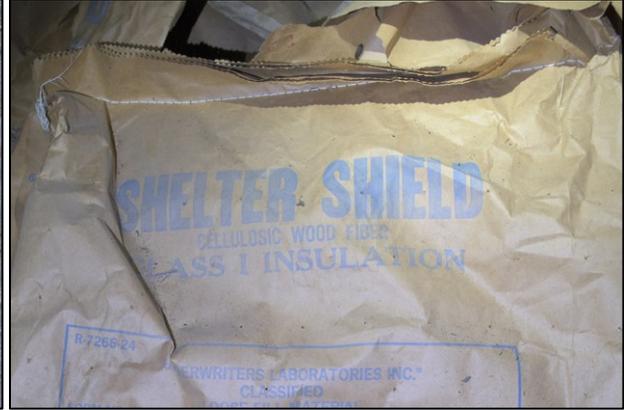
Figure 75: Late 1970s cellulose insulation bag

The extent of the wood floor is extremely difficult to determine, as large portions of the floor are covered in piles of loose cellulose insulation. Empty paper bags adjacent to the hatch indicate that the cellulose is “Shelter Shield” cellulosic wood fiber insulation, a product that was manufactured by Diversified Insulation in the United Kingdom and very popular in the United States during the energy crisis of the late 1970s (figure 75).

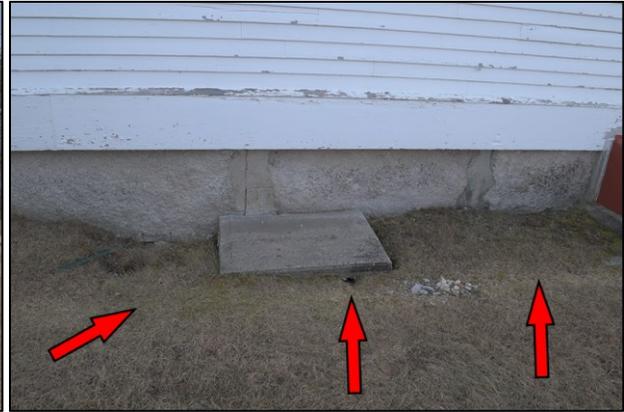
Grade – Although the siting of the Deerfield Town House on a low hill has helped with keeping water out from beneath the building, there are areas around the building where site drainage can be improved. Over time the grade against the granite underpinning has dropped a bit, and a small hump has developed beneath the drip-line, creating a flat or slightly negative grade back toward the building rather than away (figures 86 & 87). Some pea-stone at the surface of the grass at the dripline suggests that there was once a drip-edge at least along the east and west sides of the building, which has slowly been claimed by the adjacent sod.

Figure 87: Drip line at west elevation with holes where fines have eroded into the crawlspace beneath the building

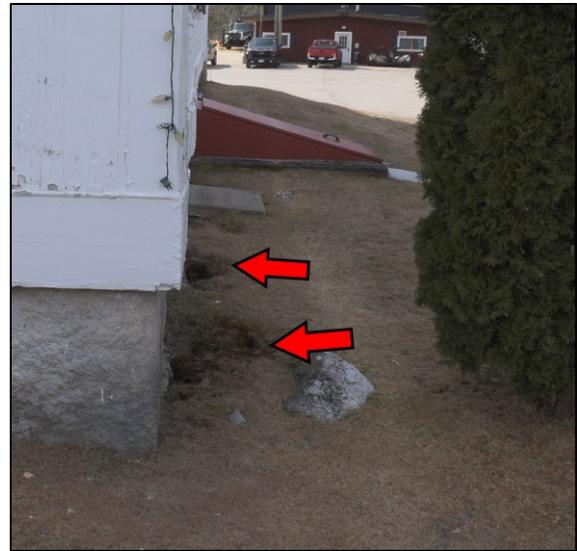
The grading issues are most visible at the northwest corner of the building, where sink holes have developed against the structure, between a medium sized *arbor vitae* shrub and the corner of the building (figure 88). Though the shrub is kept well away from the structure, it's root-ball, and that of corresponding shrub at the northeast corner of the building, has created a low mound that compound the drainage issue.

Figure 88: Sink-holes at the northwest corner of the Town House

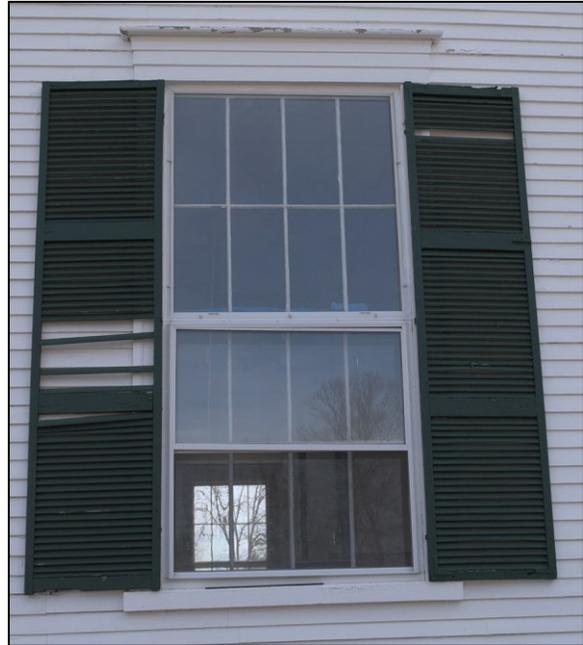
At first glance, the windows appear stable behind their mid-20th century exterior aluminum storm windows (figure 98). The trim around the windows is in good condition, with some paint loss to the sills, however, the sashes themselves are in fair to poor condition. The window glazing has failed significantly on the sash, leading to lose panes of glass, particularly at the north elevation (figure 99). Poorly ventilated storm windows appear to have created a micro-climate in some of the windows where condensation between the exterior side of the historic sash and inside of the storms has been trapped, creating a very moist environment that has caused the glazing to fail, and black mold to form (figure 100).

Figure 98: Typical Deerfield Town House Window (west elevation)

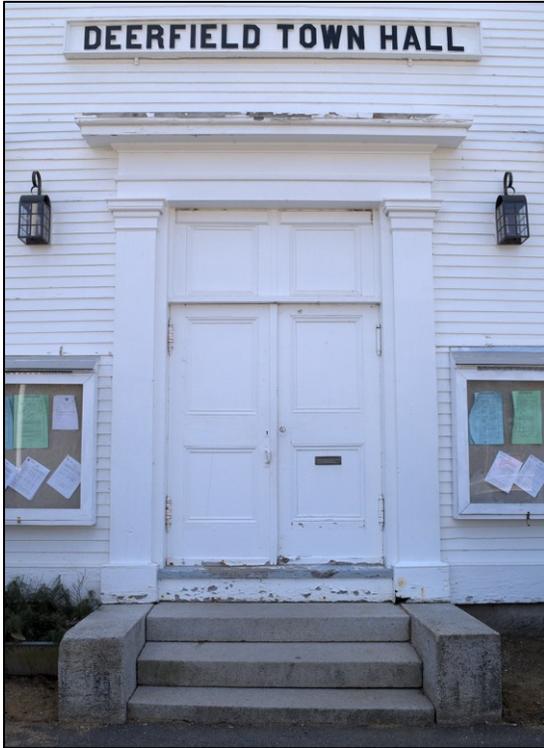
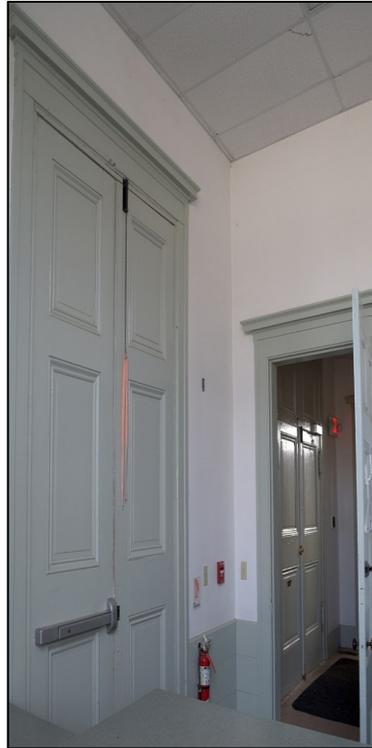
Figures 106 & 107: Primary Entrance, facing south (left) and paired exterior doors in kitchen with paired exterior doors at entrance stair at right margin of image

Exterior doors – The Deerfield Town House has five exterior doorways: three paired doors along the north elevation (primary façade), and a paired entrance next to a single exterior door at the east elevation of the 1885 addition. Generally, the exterior doors are in good working condition. As noted previously, the bottom rails of the north-facing doors at the primary façade have some damage caused from wicking water up from the wooden thresholds and several have areas of missing paint. These doors all have historic thumb-latch style handles. The door at the top of the ramp should have an accessible handle or automatic opener. Although most of the doors have crash-bars mounted on the interior, there is only a bar on one of the paired kitchen doors (figure 107).

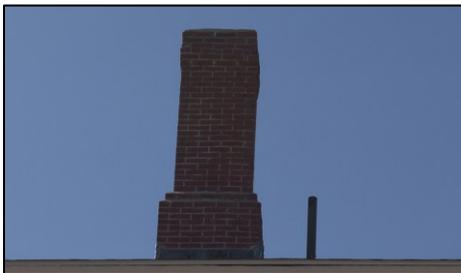
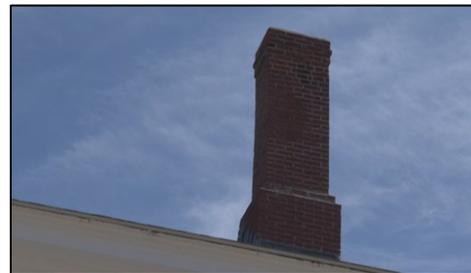
Chimneys – The two chimney stacks appear to be in good condition from the ground-level, having been repaired in 1999 (figures 108 & 109). There are no obvious signs of loose bricks or cracked and missing mortar from the ground-level. Though historic staining near the roof penetration is visible from within the building, there are no known active leaks, indicating that the flashing is in good condition.

Figure 108: East chimney

Figure 109: West chimney

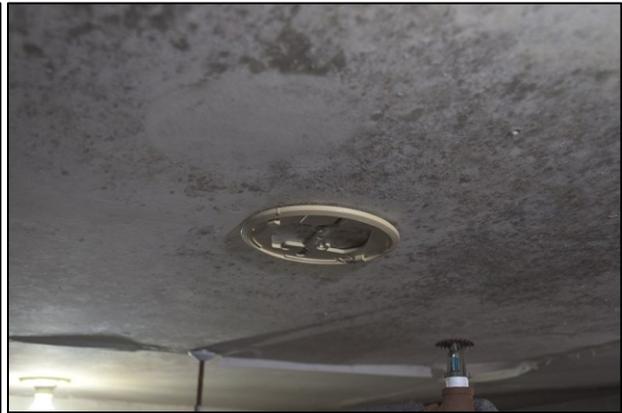
Crawlspace/Cellar – The small utility room that was excavated from beneath the midpoint of the west elevation of the building is in poor condition. The room, which was added ca. 1988, has always been plagued by moisture and was the site of a recent flood. Evidence of standing water in the space is seen by efflorescence and rusty staining to the concrete block at the interior walls, below the original crawl-space depth (figure 110). The interior walls separating the room from the adjacent crawlspace and ceiling are sheathed in gypsum board, which is flecked with black mold (figure 111). The lower section of wall at the northeast corner of the room, adjacent to the door to the crawlspace and a water spigot is severely damaged and completely rotted away, revealing the fiberglass batt insulation and 2x4 framing on which it sits (figure 112).

Figure 111: Black mold on utility room ceiling

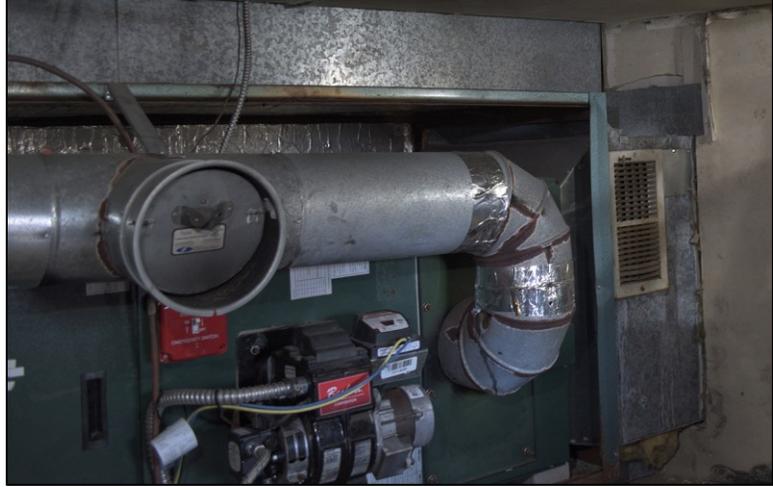
Heating & Cooling – The Deerfield Town House is heated by two oil-fired hot air furnaces which are located in the utility room beneath the west side of the building. Furnace 1, which heats the first floor of the building, was replaced approximately 10 years ago. Furnace 2, which heats the second floor was installed in 1988. The older furnace unit is nearing the end of its life. Though the town is contracted with a local HVAC company to perform annual maintenance and cleaning of the furnaces, the duct work that was observed underneath the building is rusted and uninsulated, further contributing to inefficiency.

Figure 124: One of the two furnaces

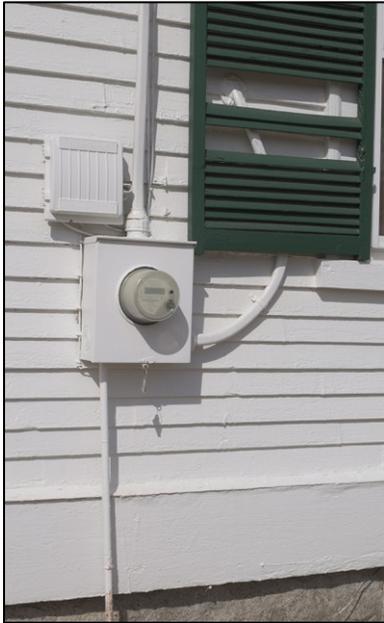
Electrical - Electrical service enters the building via overhead wires at the northeast corner of the building (figure 125). A late 20th century 200-ampere electrical panel is located within the modern utility closet adjacent to the barrier-free restroom (figure 126). A separate 2024 100-ampere sub panel is also located in this closet to run the emergency battery back-up (figure 127).

Figures 125, 126, & 127: Electrical service (left), main electrical panel (center), and new battery sub panel (right)

In the future, should the Town of Deerfield do any major repairs to the parking area/driveway to the east side of the building, they may consider moving the overhead electrical service underground to clean up the exterior appearance of the building.

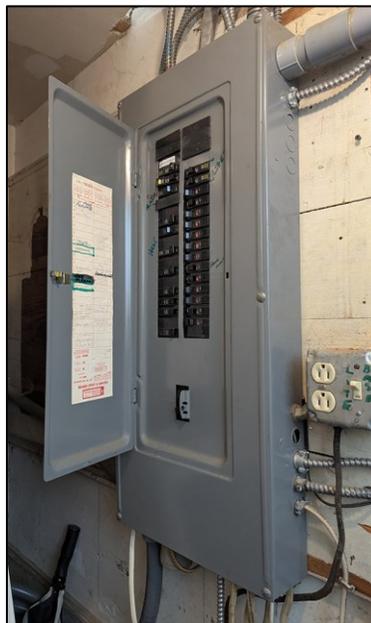
Almost all of the observed electrical wiring is modern Romex, however, a run of mid-20th century woven wire was observed leading from a switch in the main panel labeled “base lite” through the floor of the utility closet to the basement, suggesting that at least one run of wire was not updated in the 1990s.

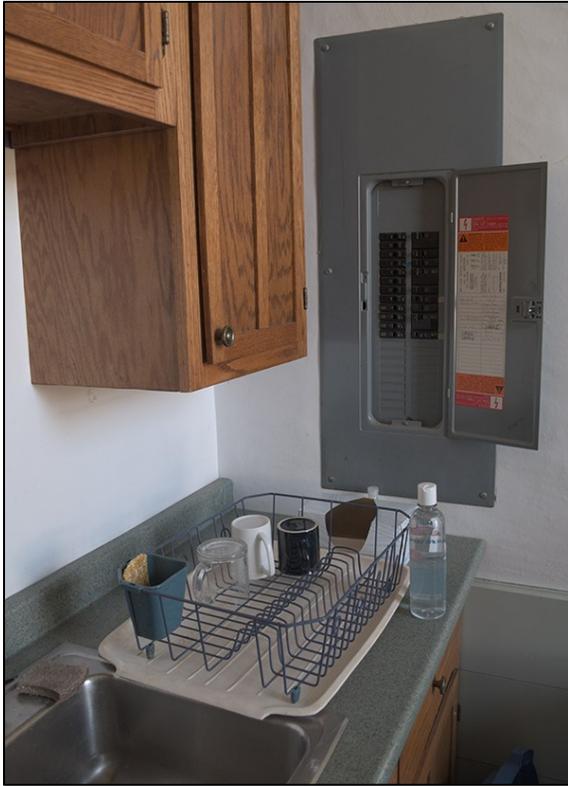
Figure 129: Kitchen sub-panel

Smaller sub-panels are located next to the sink in the kitchen and in the backstage area (figures 128 & 129). During public events, such as the Coffeehouse, the sub-panel in the kitchen (which has no localized shut-off breaker) is prone to tripping when too many crock pots are plugged in at once. This sub-panel, which was installed in ca. 1990, is also noted to be less than 3 feet from the sink. Though the capacity of the kitchen sub-panel is unclear (likely 100-ampere but unlabeled), the sub-panel at the backstage area is labeled as 100-ampere.

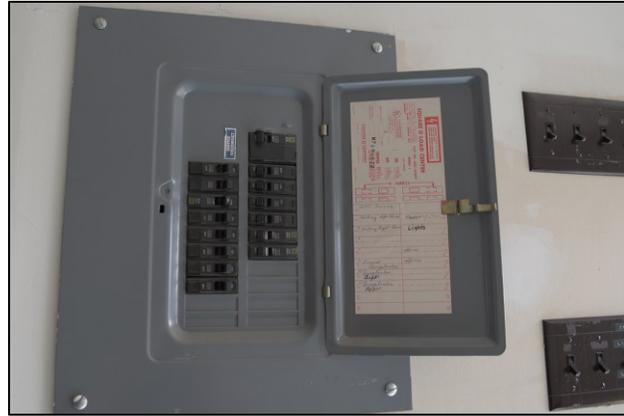
Figure 128: Backstage area sub-panel
